MARYLAND HISTORICAL TRUST DETERMINATION OF ELIGIBILITY FORM

Property Name: SHA Bridge No. 1603800, MD 212 over Indian Creek	Inventory Number: PG: 61-27					
Address: Powder Mill Road (MD 212)	_ Historic district: yes X no					
City: Greenbelt Zip Code: 20770	County: Prince Georges					
USGS Quadrangle(s): Beltsville						
Property Owner: State Highway Administration	Tax Account ID Number:					
Tax Map Parcel Number(s): Tax Map Num	ber:					
Project: Reevaluation of Highway Bridges Statewide Agence	cy: FHWA/MD SHA					
Agency Prepared By: KCI Technologies, Inc.						
Preparer's Name: Kim Sebestyen	Date Prepared: 10/16/2009					
Documentation is presented in: Project Review and Compliance Files						
Preparer's Eligibility Recommendation: X Eligibility recommended	d Eligibility not recommended					
Criteria: X A B X C D Considerations: A	BCDEFG					
Complete if the property is a contributing or non-contributing resour	rce to a NR district/property					
Name of the District/Property:

MIHP No. PG;61-27 SHA Bridge No. 1603800 MD 212 over Indian Creek Prince George's County, Maryland

MARYLAND HISTORICAL TRUST ADDENDUM SHEET Montgomery-Prince George's Short-term Congestion Relief

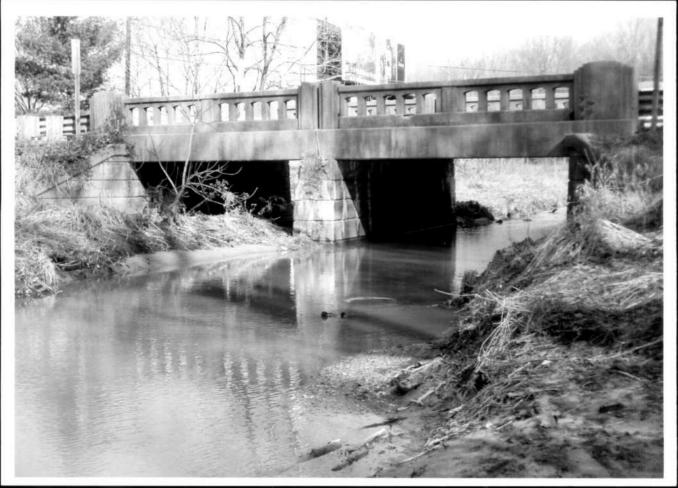
MIHP No. PG; 61-27 MD 212 over SHA Bridge No. 1603800/ Indian Creek P66 MD Kimbery Schanger 1/12/09 South elevation facing north

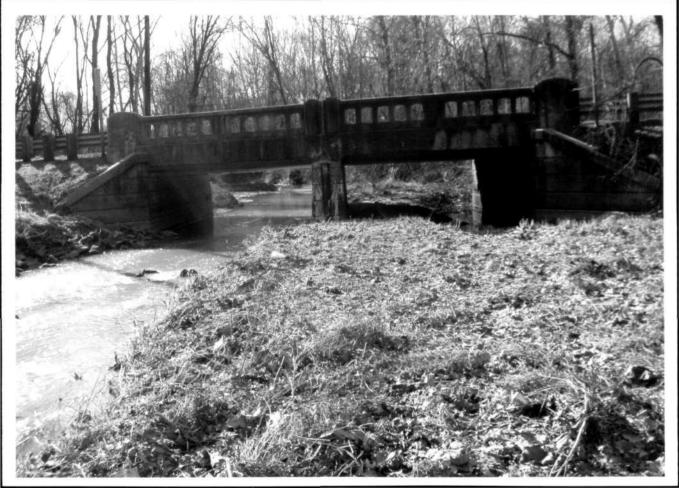
MINP No. PG, 81-27 SHA Bridge 160200 / Indian Rum Pla 60- MD K. Schesten 1/12/09 MD SUPPOSO N. elev. Facing S.

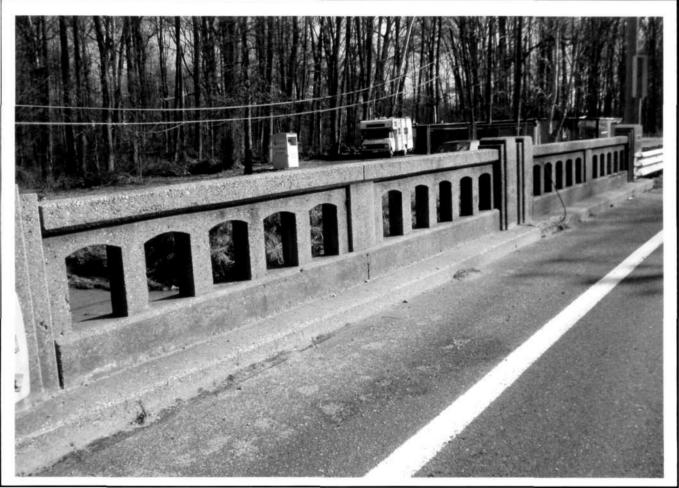
MIHP No. PG; 61-27 Mi) 212 over SHA Bridge No. 1603800/ Indian Run PG Co. MD L. Subestyper MD SUPD 1/12/09 N. Pewapet Wall, Riche NE

The superstructure was given a rating of 6 in the 2007 BIR; this rating has remained the same since 1995. The 2009 field survey noted that the walls have minor cracking and spalling with some visible aggregate and rusted rebar. Modern W-beam guardrails were attached at each of the corners by bolting them through both sides of the walls. The parapet walls have a non-standard desig with Streamline Moderne influence (MIHP form, SHA Bridge Plans 1937). The underside of the deck has some minor cracking a well as a few larger cracks with efflorescence and dripping stalactites. Previous concrete repairs under the deck are cracking.

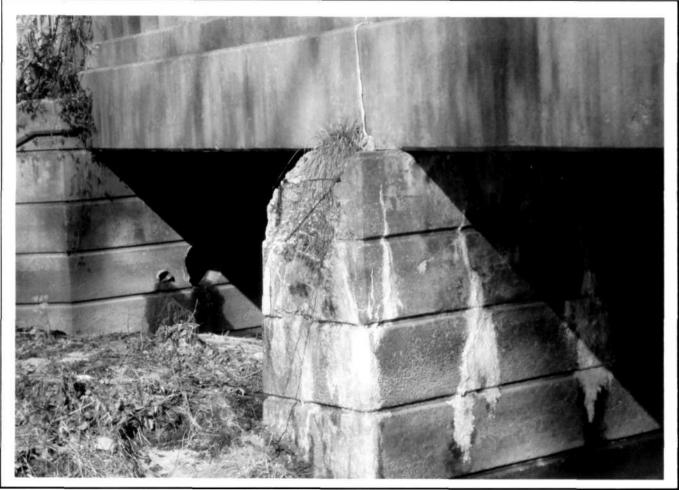
MIHP Nb. P6; 61-27 MD 212 over SHA Bridge No. 16038 00 / Indian Creak PG CO. MDON K. Scheshen MD SHPD 1/12/09 S. elev. Pier, Fring New EPSON

The substructure was given a rating of 6 in the 2007 BIR; this rating has remained the same since 1995. The pier has deteriorating concrete on both ends. The north end of the pier is scaled at the top back to the slab and has cracks and heavy efflorescence. The metal pier nose cap is exposed and heavily rusting. The south pier has heavy deterioration of the top two feet of material with exposed rusted rebar. There is heavy efflorescence, cracking, and rust stains across the front of the pier. There are cracks and efflorescence across both sides of the pier. The abutments have several full-height, open cracks and moderate scaling, with scour along the waterline. The wingwalls have minor cracking and efflorescence.

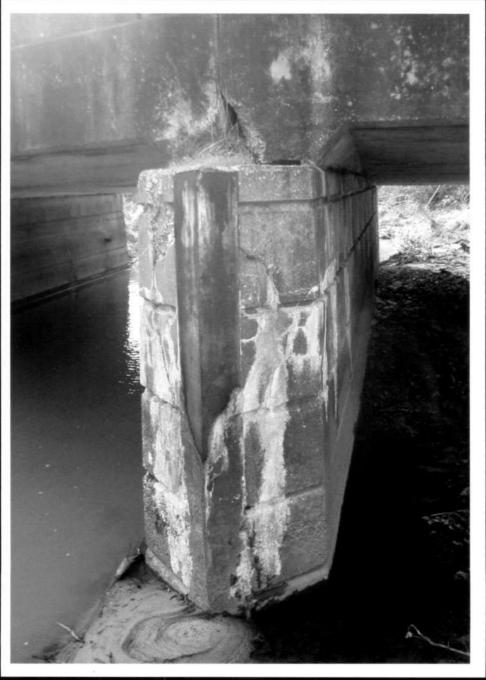
MIHP No. PG; 61-27 SHA Bridge No. 1603800 MD 212 over Indian Creek Pla Co. MD K. Schestyen /12/0950 MD SHPD Pier northerd, Facing Ses 5/5

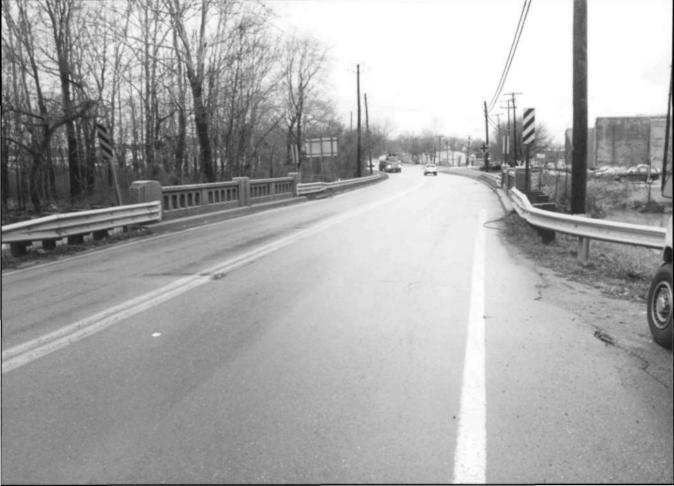
Name 16038- MD 2	12 WER INDIAN CREE
County/State PRINCE	GEORGES COUNTY MG
Name of Photographer _	WALLY KING
Date 195	
Location of Negative	SHA
Description EAST	APPROACH LOOKING
WEST	
Number 4 of 344

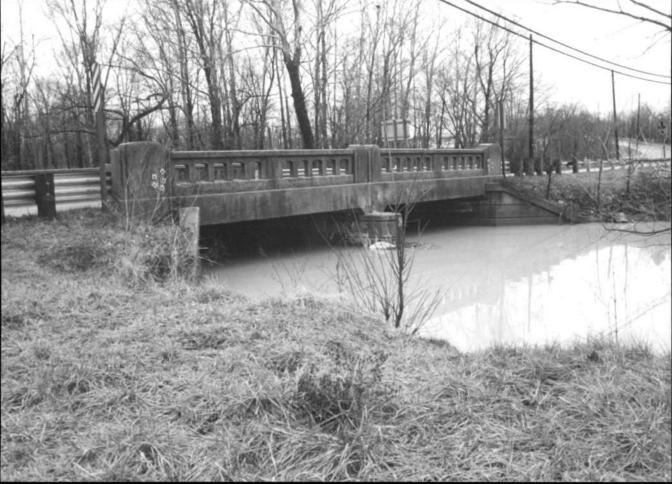
Name 16038-MO 212 OVER INDIAN CRE County/State PRINCE GEORGES COUNTY Name of Photographer WALLY KING	
Date 195 Location of Negative SHA	
Description NORTH ELEVATION	
Number 5 of 24 4

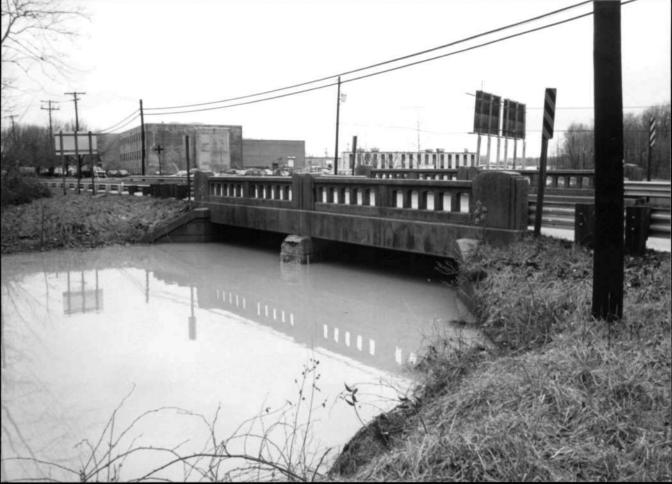
AN CREEK
County/State	PRINCE	GELRGES	COUNTY /MD
Name of Phot	ographer _	WALLYKIR)G
Date \\	15		
Location of N	egative	SHA	
Description _	South	ELEVATI	011
3	4

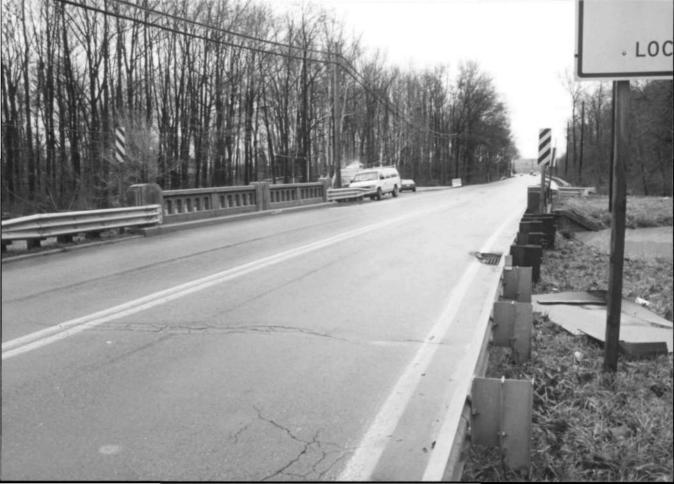
Name 16038-MOZIZ OVER INDIAN CREEK
County/State PRINCE GEORGES COUNTY/ME
Name of Photographer WALLY KING Date 195
Location of Negative 5HA
Description WEST MARROACH LOOKING EAS
Number 7 of 24

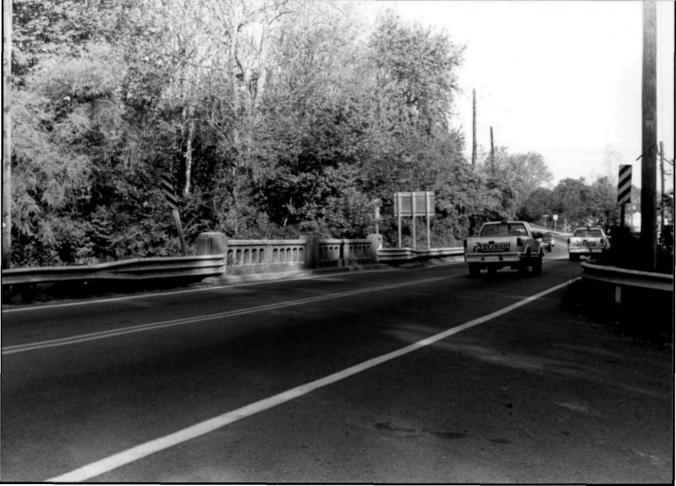
PG: 61-27 2 Bridge 16038 3 Prince Georges Co. Md 4 Susan Jaylor 6 NID SHIPO 1 E approach 8 /of 5

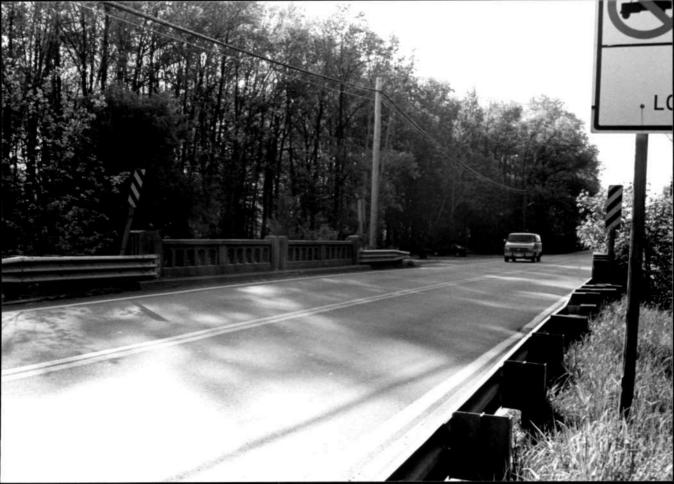
PG: 61-27 2 Budge 16038 3 Prince Deoges Co, Md 4. Susan Daylor 5 5 98 6 MD SHPO 1 W approach 82015

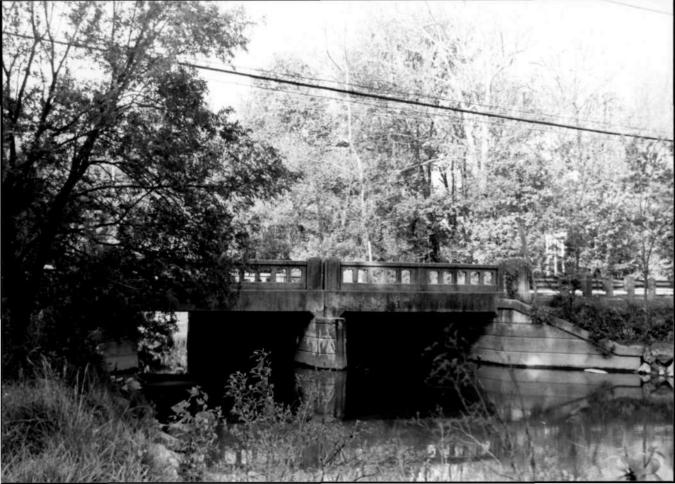
PG: 61-27 2 Budge 16038 3 Punce Georges Co, Md 4 Susan Saylor 5 5/98 6 Md SHPO 7 Nelevation 8 3045

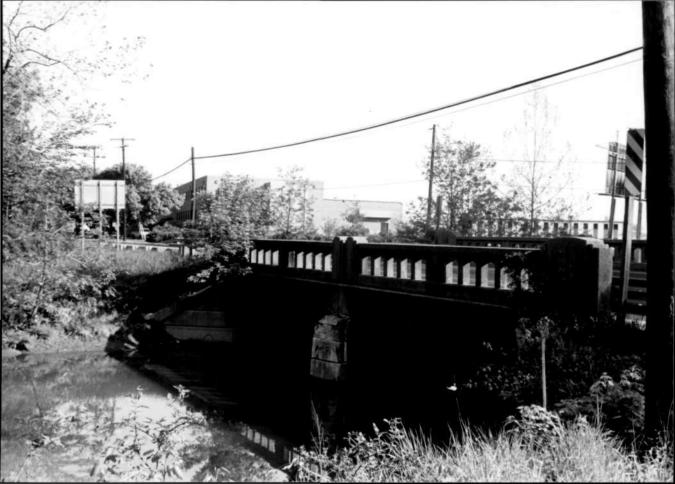
PG 61-27 2 Bridge 16038 3 Prince Deorges Co Md 4 Swan Daylor 5 5/98 6 MOSTIPO 1 I elevation 8 4 85

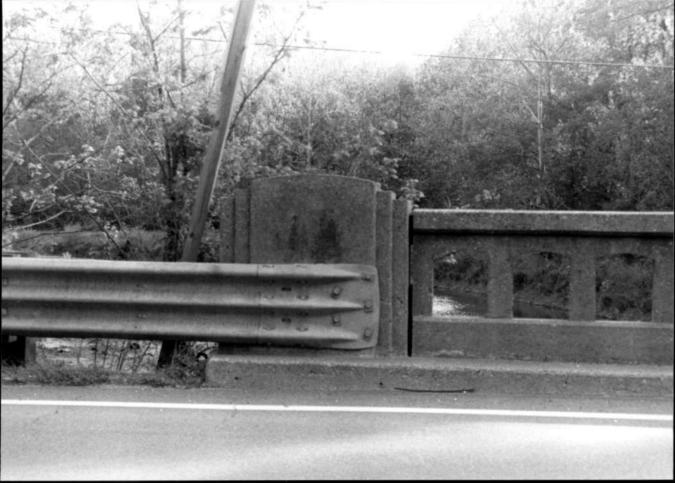
PG: 61-27 2 Budge 16038 3 Prince Georges Co, Mal 4 Dusan Daylor 5 5/98 6 MO SHPO 7 End Block, de tail 650f5

The bridge is a 2-span, 2-lane concrete slab bridge. It has pierced parapets and stylized endblocks. The bridge is unchanged from the previous survey.
